# Slope Field Mapping and Findings at Ulu Klang Area, Malaysia

Ashaari bin Mohamad<sup>1</sup>, Shabri Shaharom<sup>1</sup>, Mahadzer Mahmud<sup>3</sup>, Nik Ramalan Nik Hassan<sup>2</sup>,  
Mohd Fadlee Baba<sup>3</sup>, Saravanan Mariappan<sup>2</sup>, Low Tian Huat<sup>4</sup>, Steven Chong<sup>2</sup>,  
Md Zaini Madi<sup>5</sup>, Wan Mohd Razziff Wan Ishak<sup>6</sup>

<sup>1</sup>Slope Engineering Branch, Public Works Department Malaysia, <sup>2</sup>Enceal Consultants Sdn Bhd, Malaysia,  
<sup>3</sup>Kumpulan Ikram Sdn Bhd, Malaysia, <sup>4</sup>Mohd Asbi & Associates, Malaysia, <sup>5</sup>Opus Bhd, <sup>6</sup>Perunding ZMS Sdn Bhd,  
e-mail: vanan\_nexus@yahoo.com.sg

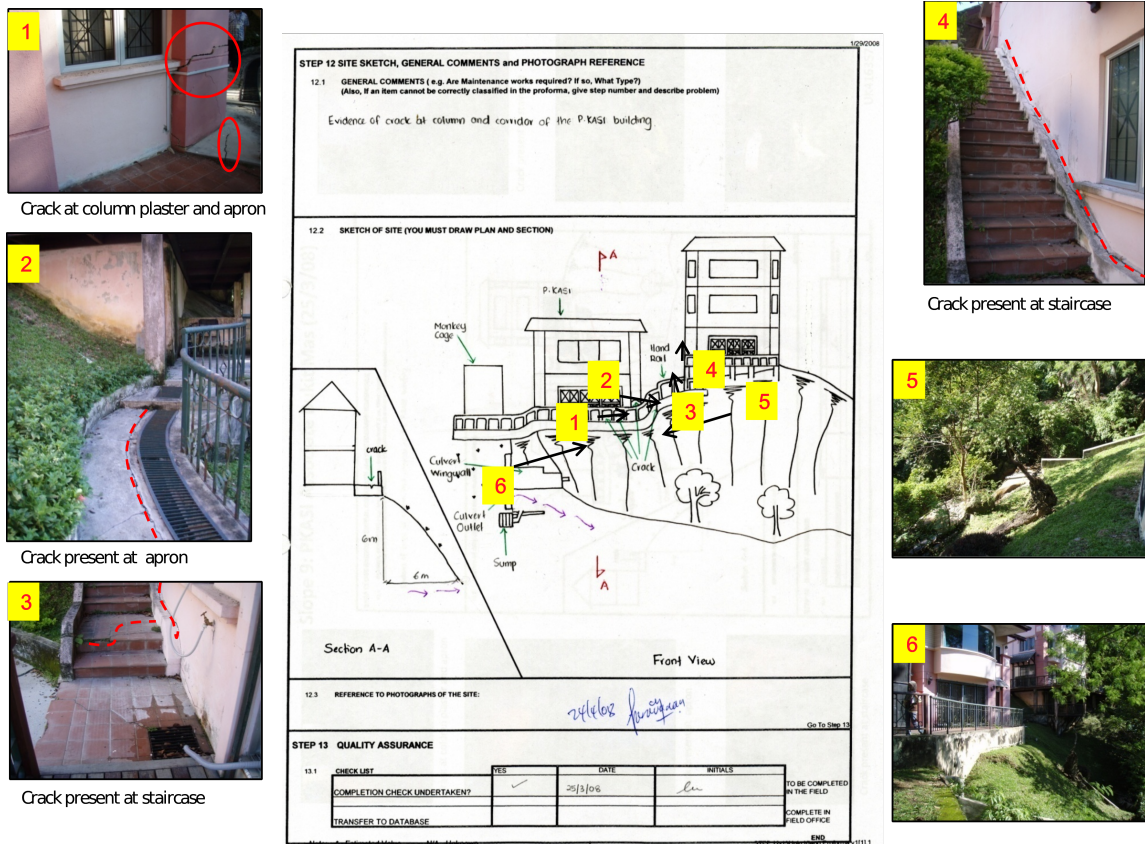
Figure 2 : shows an example of field geomorphological survey done for a soil slope, with a bungalow on top of slope showing signs of distress, with cracks on apron slopes and columns.

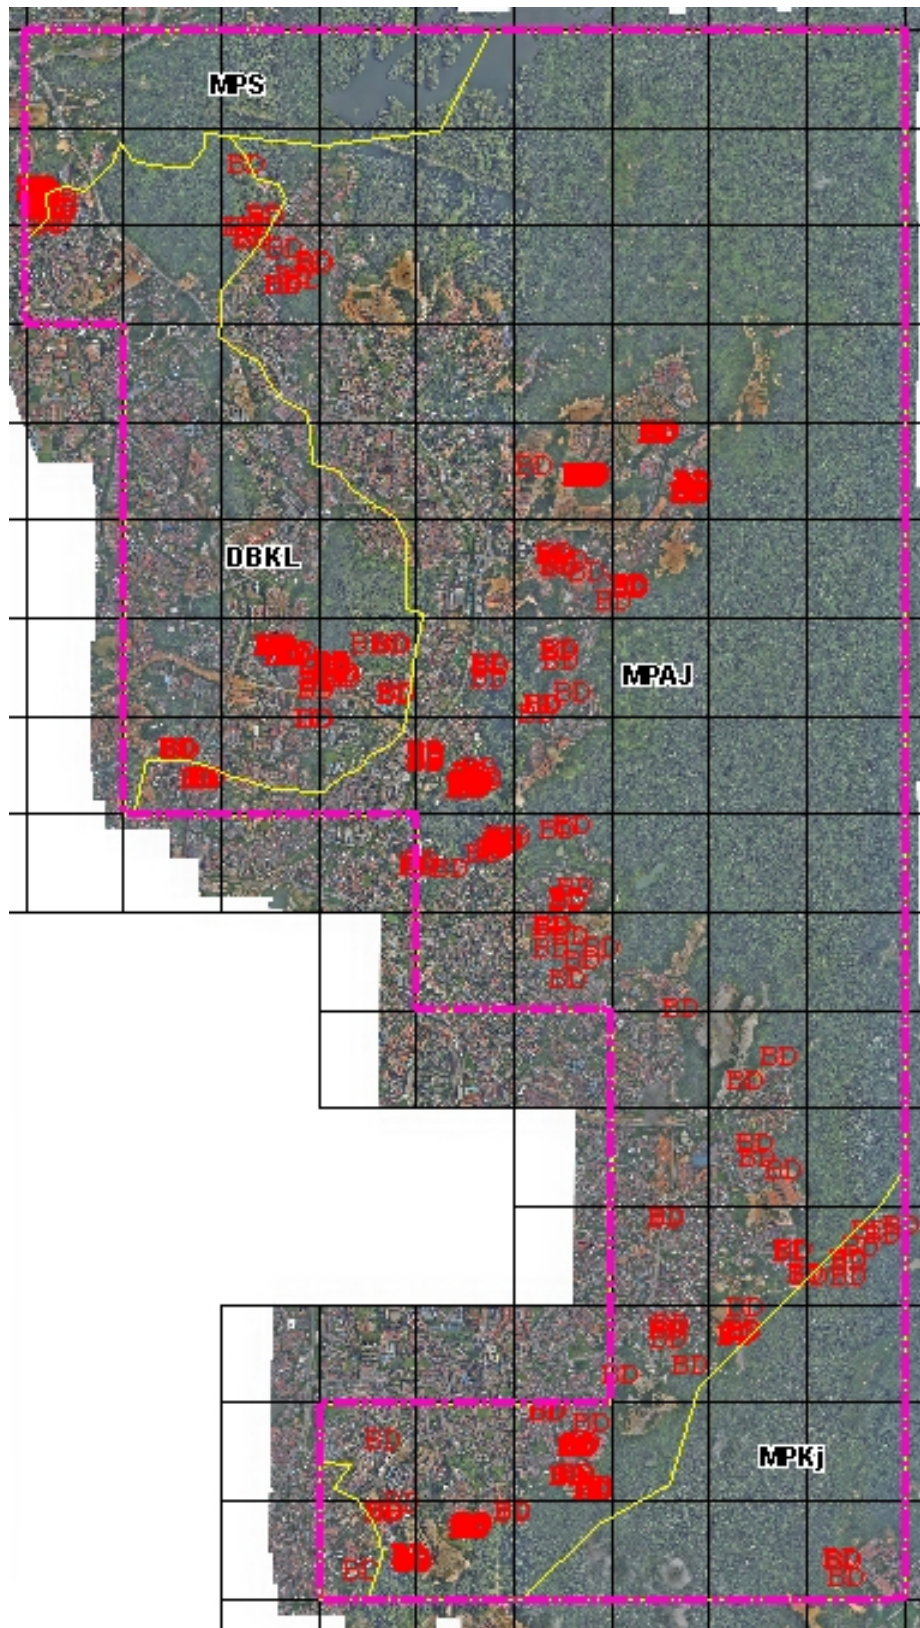
Typical locations with defects or attention required are shown in Figure 3 as a geomorphological map.

Figure 3 : Geomorphology Map showing areas with blocked drain

- Another main factor causing slope failures are due to poorly maintained drainage system for slopes, this study have also identified the areas which requires improvement in the drainage system. The needs to conduct regular maintenance and repair works are critical in Ampang area. There are areas with no drainage system to prevent surface runoff, water ponding and infiltration.
