Remedial Measures Adopted for Slope Failure at Bukit Antarabangsa, Malaysia

ABSTRACT: A section of slope collapsed at the district of Gombak (Ulu Klang) Selangor, well known as Bukit Antarabangsa residential area, killing 4 residents and injuring 14 others. The debris from the landslides completely blocked the only access road, to the neighbouring residential areas, leaving about 2000 residents stranded without access. The landslide took place at approximately 3.30 am, on 6th December 2008, measuring about 109m width at the crest, 120m in length and 15m in depth. An estimated of 101,500 cubic meter of earth had translated to a maximum run off distance of about 214m from the toe of slope. Emergency measures were undertaken to perform search and rescue, to evacuate the houses next to failure, provide access to the stranded residents, reinstate damage monsoon drain and other major utilities. Most importantly is to repair the failed slope in order to prevent further failure or damage to the houses facing the failure crest. This paper address the details of the geotechnical remedial works carried out reinstate the failed slope and the type of remedial works were adopted to stabilize ne

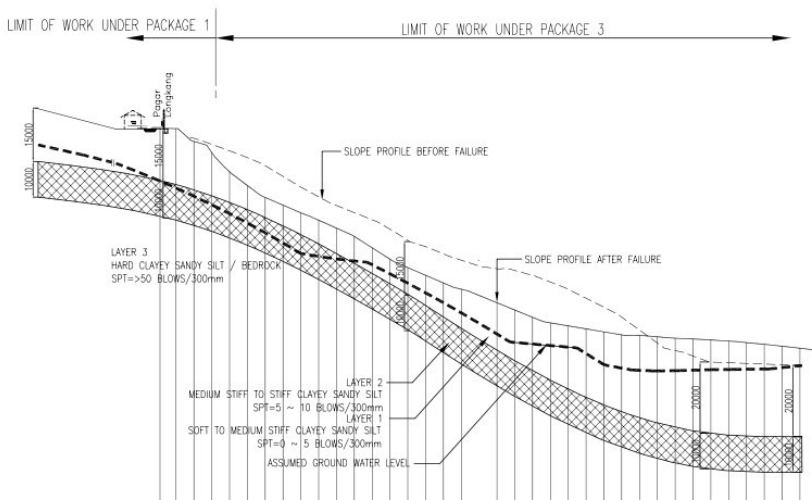
Figure 3.0: Cross section of subsoil stratum along the slope profile at main failure area

- Subsurface stratification forming the slope profile is assumed to range from soft to hard clayey sandy silt.
- Primary cause of slope failure is attributed to rise in ground water level due to prolong rainfall, continuous creep of slope over along period of time, sustained saturation of the slope at pockets of voids within the slope mass, as the slope were constructed by means of end tipping.

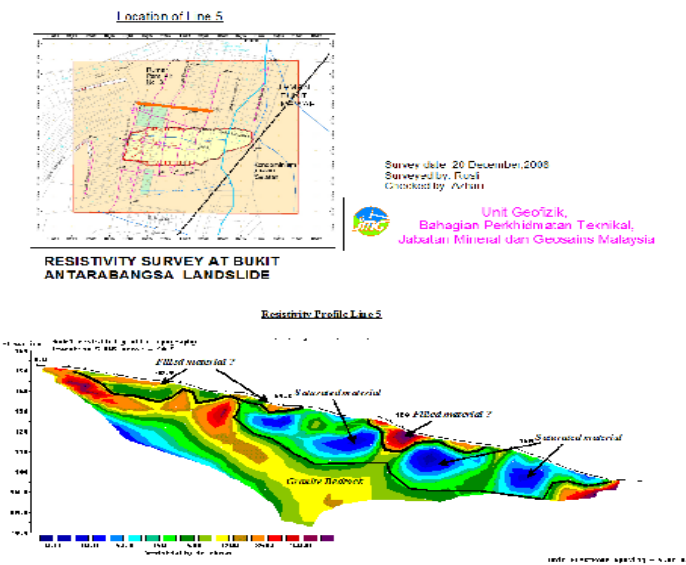
Figure 4.0: Shows the resistivity test result conducted by JMG (Department of Mineral and Geoscience)

Figure 4.0 shows the resistivity test result conducted by JMG (Department of Mineral and Geoscience) indicating pockets of loose material. The presents of these pockets of loose material indicates the slope is a filled slope with poorly or not compacted fill (end tripped slope)

- Pressure grouting was proposed together with the soil nail installation to ensure the soil nails gain appropriate anchorage friction especially at the loose pockets. Based on the Resistivity Test by JMG, approximately 20% of the slope area contains loose pockets. Therefore this 20% of slope area has to be covered with grout, in order to strengthen the slope.
- **Table 2** shows the Factor of Safety obtained based on the studied cross section at Package 2, the Factor of Safety (FOS) achieves 1.53 with the usage of caisson pile. This in return, complies to the project requirement of FOS 1.5.

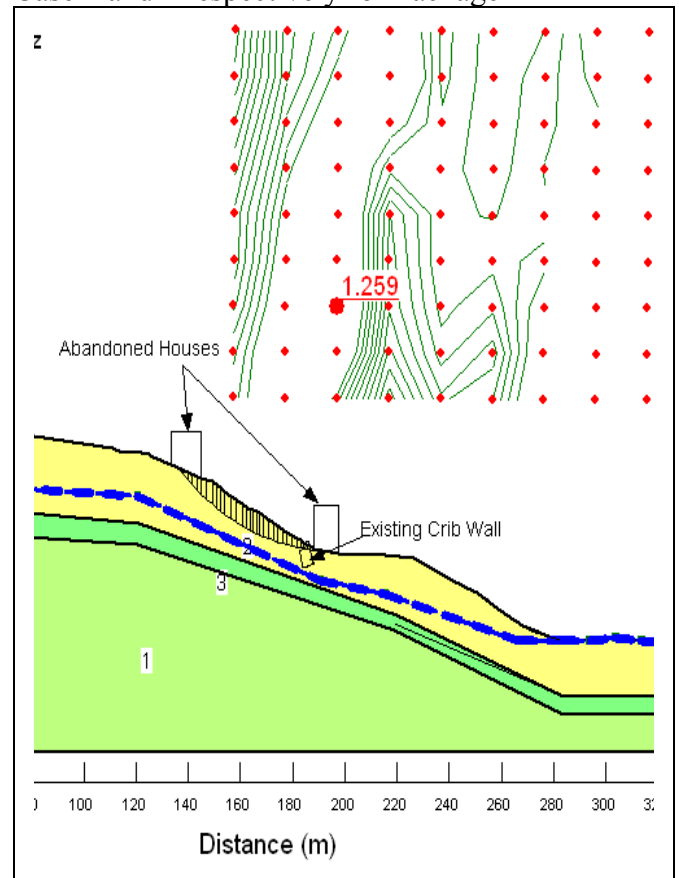
Figure 5.0: Case 1 – Existing slope without treatment (Package 2)

Case	Slope Condition	Factor Of Safety
1	Existing Slope without Treatment	1.26
2	Soil Nailing and Caisson Pile	1.53

- Construction of 30m deep caisson pile wall (diameter of 1.5m, spaced at 2m centers) to intercept the failure plane in order minimize potential global instability and to ensure sufficient socketing into hard stratum were obtained.
- Installation of soil nails with T32 tendon and pressure grouting the nails. This system was used to overcome the localized failure of the existing slope.

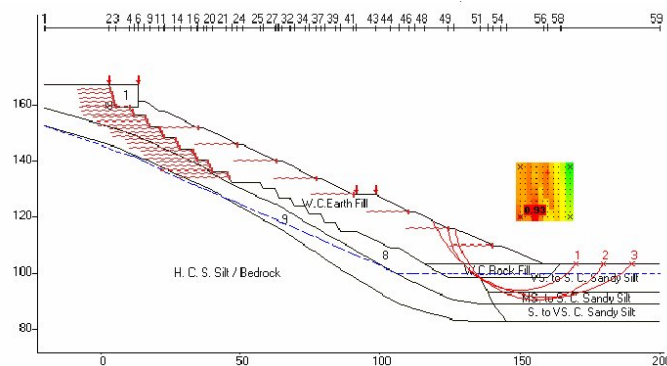
Figure 7.0 : Case 5 – Shallow basal failure of the toe without reinforcement

5	Shallow basal failure of the toe without reinforcement	0.93	<ul style="list-style-type: none"> • Provide high strength geotextile reinforcement HS 400/50 	Insufficient
6	Shallow basal failure of the toe with high strength geotextile	1.11		Insufficient
7	Deep sited basal failure beyond the toe of bottom row caisson	1.67	<ul style="list-style-type: none"> • Caissons are required to be installed to a minimum depth of 25m to obtain deep sited failure 	Sufficient
Overall Stability				
8	Overall stability of the proposed remedial works	1.45	<ul style="list-style-type: none"> • Caisson at mid level and toe level • High strength geotextile at soffit of rock fill • Soil nails to stabilize temporary excavation • Geogrid at fill slope 	Adequate
9	Overall stability of proposed remedial works with mid level caisson	1.65		Adequate (enhanced)
