Remedial Measures Adopted for Slope Failure at Bukit Antarabangsa, Malaysia

ABSTRACT: A section of slope collapsed at the district of Gombak (Ulu Klang) Selangor, well known as Bukit Antarabangsa residential area, killing 4 residents and injuring 14 others. The debris from the landslides completely blocked the only access road, to the neighbouring residential areas, leaving about 2000 residents stranded without access. The landslide took place at approximately 3.30 am, on 6th December 2008, measuring about 109m width at the crest, 120m in length and 15m in depth. An estimated of 101,500 cubic meter of earth had translated to a maximum run off distance of about 214m from the toe of slope. Emergency measures were undertaken to perform search and rescue, to evacuate the houses next to failure, provide access to the stranded residents, reinstate damage monsoon drain and other major utilities. Most importantly is to repair the failed slope in order to prevent further failure or damage to the houses facing the failure crest. This paper address the details of the geotechnical remedial works carried out reinstate the failed slope and the type of remedial works were adopted to stabilize ne

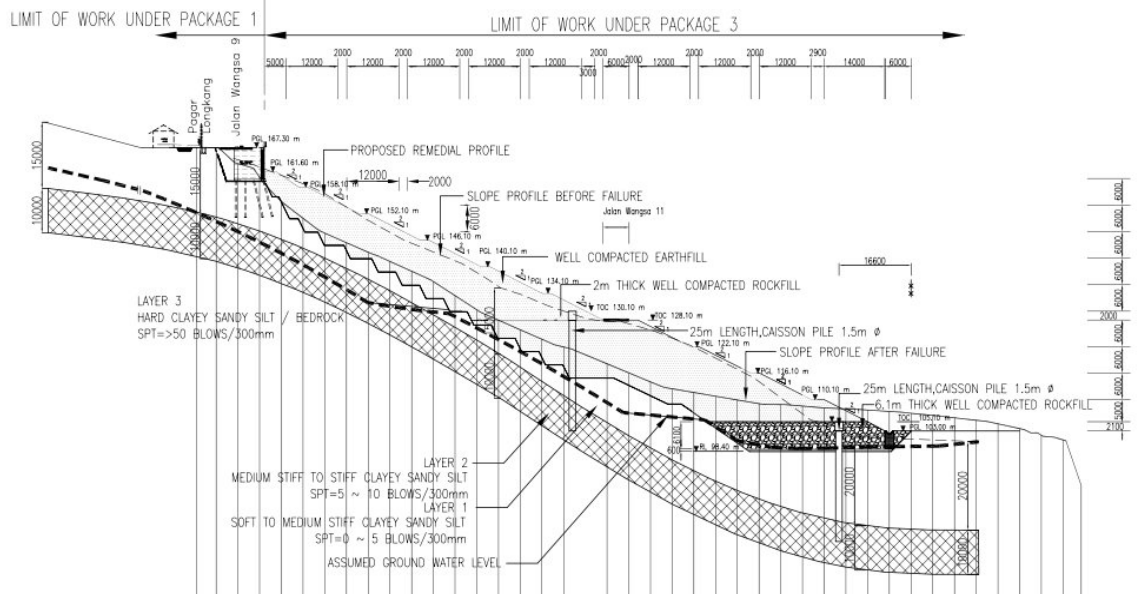
Figure 10.0: Typical cross section of the proposed remedial works incooperated with subsoil stratification

The typical cross section of the proposed remedial works with in-cooperated subsoil stratification is shown in **Figures 10.0**. The proposed remedial slope is analysis for
